# EM0814-83A, EM0818-82X, EM0819-80X

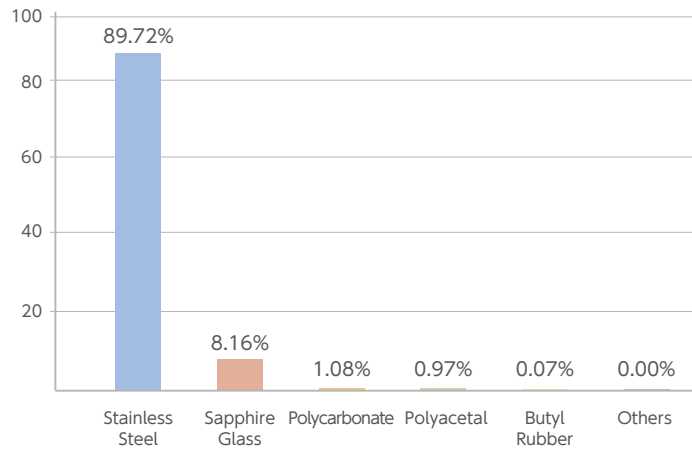
exterior

Stainless Steel 89.72%	
Iron	61.91
Chromium	15.25
Nickel	10.77
Molybdenum	1.79

\*Substances at a level contained below 0.05% are not listed.
